Technical Guide

Guide to Assessment and Repair of Flood Damaged Timber and Timber Framed Houses

(Revised 2nd Feb 2013)

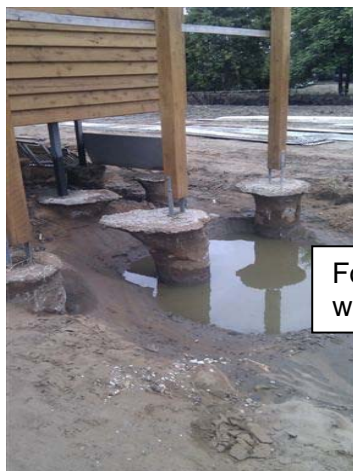
Footings scoured out by fast flowing water

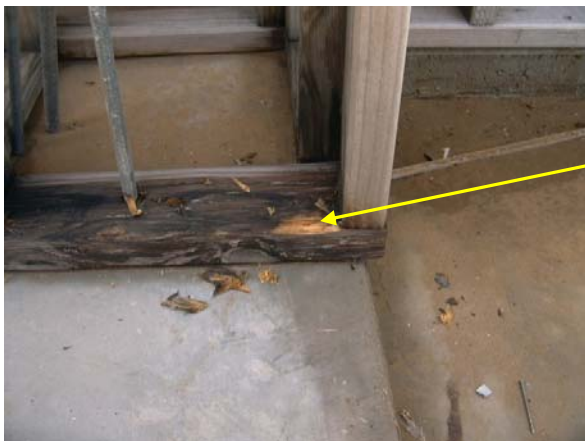
Although heavily discoloured with surface mould and blue stain, the pine timber is still sound as shown by scraping back the surface layer

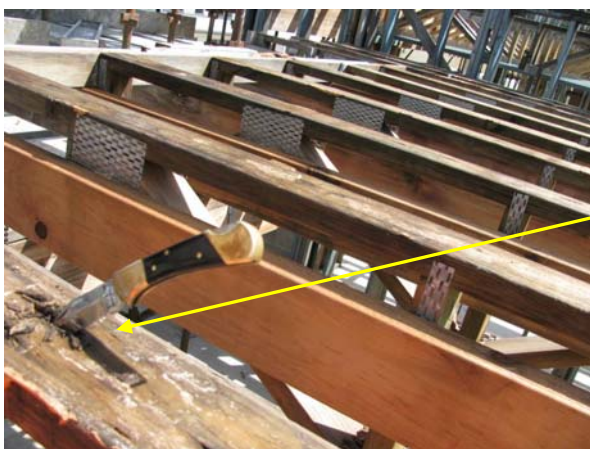
Decayed timber is soft and spongy and can easily be penetrated with a knife or screwdriver

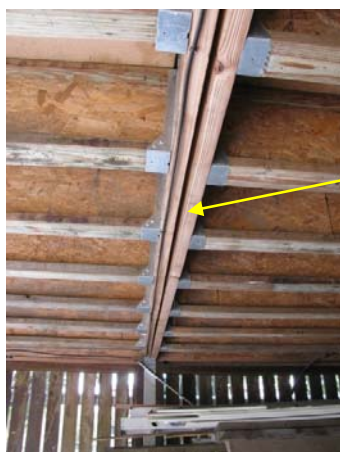
Expansion of the hardwood T&G floor above has caused the separation of double bearers.

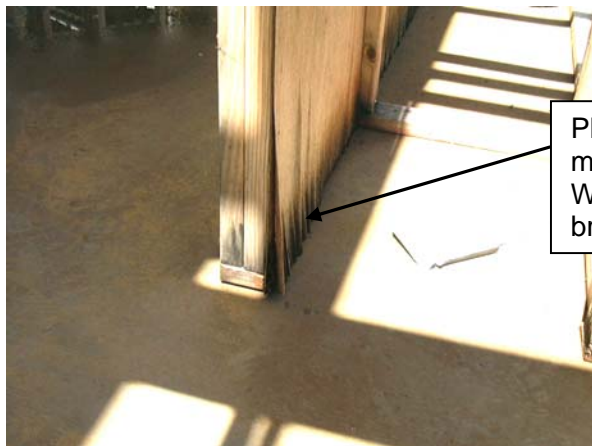
Plywood sheet bracing affected by moisture. Replacement required. Where necessary fix temporary braces.

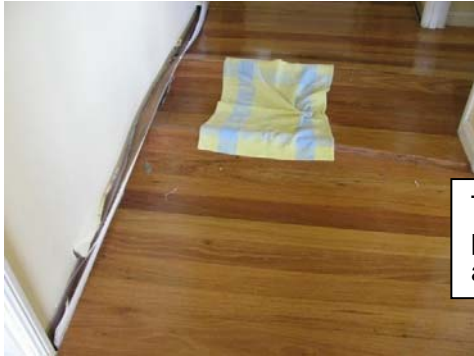
This inundated T&G floor over particleboard tented about 1 week after the water receded.

Allow the flooring a minimum of 4 months to dry out before re-assessing. Gaps between boards are highly likely to occur as the floor dries out, however the structural adequacy of the flooring is not likely to have been compromised and floors may be lived on in the meantime.
