PLASTERBOARD RECTIFICATION RESULTING FROM FLOOD INUNDATION, 2017

The AWCI Queensland provides this basic Home Owners' information for flood affected linings regarding assessment and different processes involved in rectification.

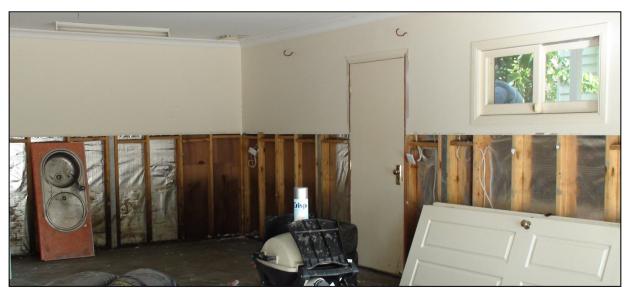
Method 1

Remove the damaged sheets to approximately 300mm above the high water mark preferably at the nearest joint above the water line. Given sheets are either 1200 mm or 1350 mm high it will either be at these joints or at full wall height (see method 2 below).

Because the replacement joint will most likely be made up of one new recessed edge board abutting the existing sheet (a butt edge), the joint should be treated as a butt joint. There will be a crown created which may cause glancing light issues and setting out over 600mm (the same as a butt joint) will reduce the noticeability of the crown. See the Australian Standard AS/NZS 2589:2007 (Figure 4.4.5) for more information on setting out for butt joints. Note: A decorative dado rail may also be used over the new join without the requirement of trowelling.
