**HOW TO SIMPLY
IDENTIFY
A DAMP HOUSE**

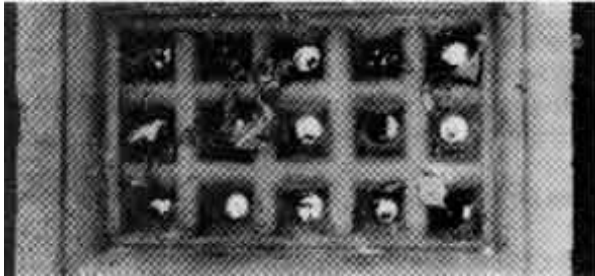
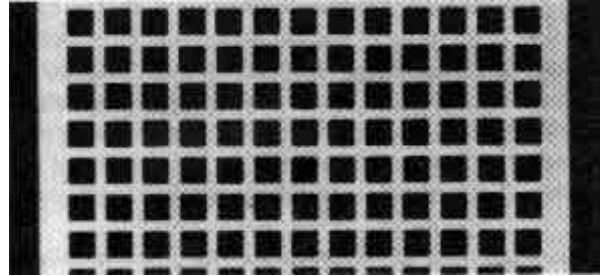
Figure 1.

Terra Cotta Vents

Pressed Metal Vents

All present vents should be clear. If a building is in a damp area and had insufficient sub-floor ventilation in the past, then the timber floors and stumps could be in poor condition. Terra cotta vents as in Edwardian houses are very poor ventilators and are part of the cause of floor problems in such buildings. (See Figure 1)
