**THIS AMAZING TOOL
WILL HELP YOU
PREVENT DEFECTS IN
BRICK AND
BLOCKWORK,
CONCRETE WORK,
WINDOW INSTALLATION
AND TIMBER DECKS.**

Common Defects in

BRICK & BLOCKWORK

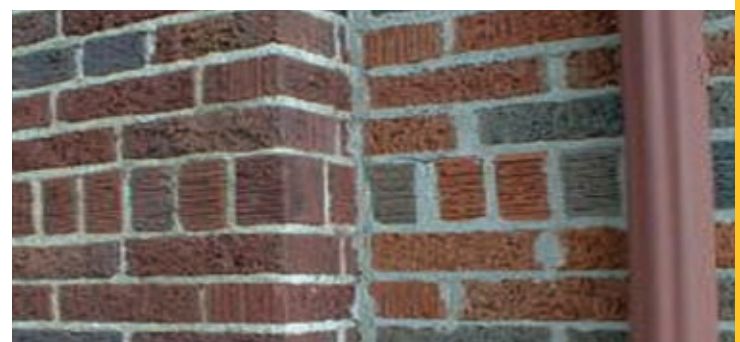
Colour differences in brick work can be a subjective issue

Colour blending of brickwork is an extremely subjective issue, what may be acceptable to one person may be unacceptable to others. The best advice BSA can give in relation to such issues is to clearly discuss any required colour blending with the builder and client prior to commencement of work.

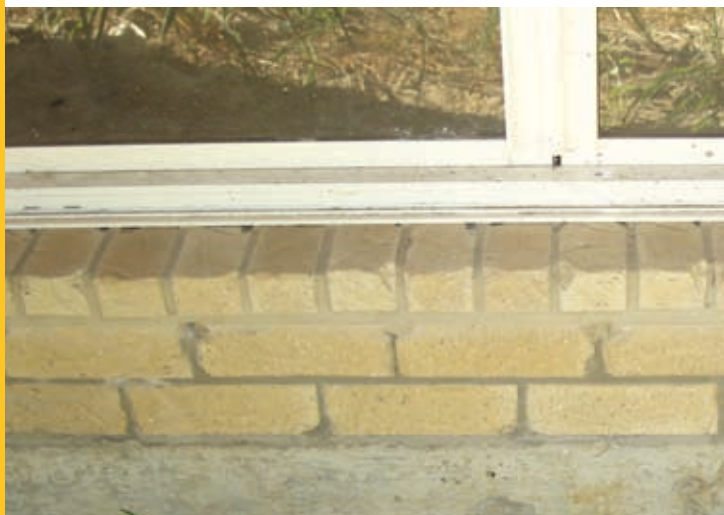
Mortar joint of variable width and significantly exceeding 10mm in places.

In relation to **joint and perpend widths** the Building Code of Australia and Australian Standard AS 3700 provide that unless specified otherwise and brickwork designed accordingly, the masonry bed and perpend joints should be 10mm. The Standard however permits a plus or minus 3mm tolerance for deviation from the specified thickness.

Once again however, lack of attention to detail or perhaps lack of care with their work has resulted in a number of complaints being lodged with BSA against builders and brick layers in relation to inconsistent mortar bed or perpend thickness.

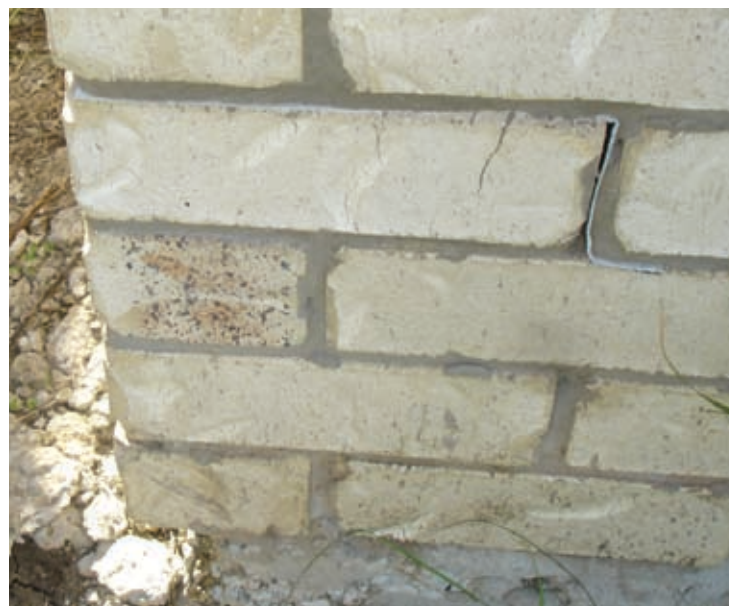
First course significantly overhanging slab edge

Building a wall out of plumb to accommodate mistakes made by the carpenters in setting out the fascia may result in the bricklayer being required to demolish or rectify defective brickwork that is the result of problems caused by other trades. Similar problems arise when footings are poured out of alignment and brickwork excessively overhangs the edge of the footing.

Where such overhang is excessive the issue must be referred back to the builder for resolution prior to laying the first course of bricks. Having to demolish inadequately supported brick walls or to rectify brick walls that subsequently crack or dislodge because they have been inadequately supported is distressing to clients and costly to both builders and bricklayers.

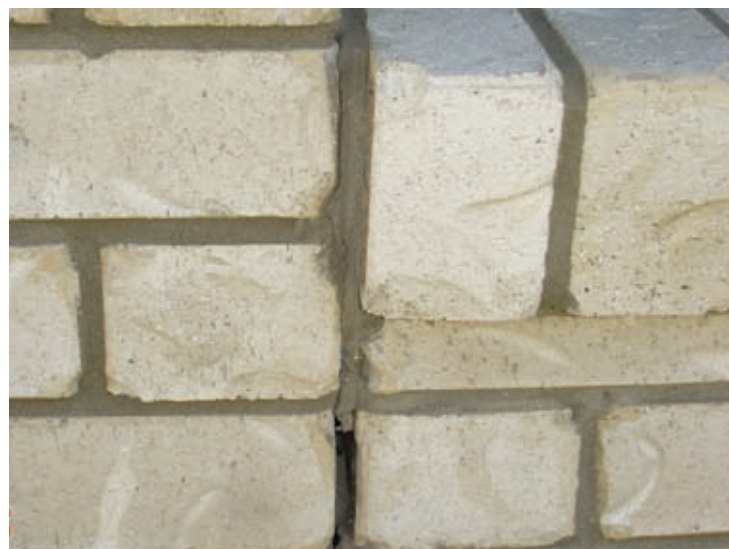
Articulation joint not carried through sill

Additionally, joints often fail to be taken through the mortar in brick sills subsequently resulting in cracking of the mortar in the sills and even bricks becoming dislodged.

Other problems include the joints being breached by mortar or other non-compressible material and joints being cut-in after construction rather than being built-in as construction proceeds. In such cases the joints are seldom the required 10mm minimum width as cutting blades are typically only 3 or 4mm thickness.

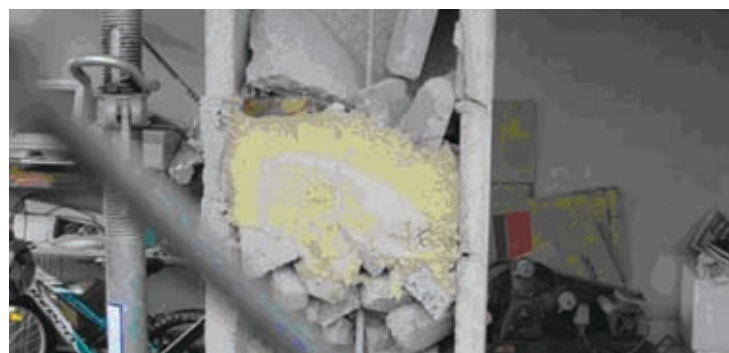
Core filled pier discovered after Cyclone Larry showing almost non-existent core filling

Common problems include inadequate cleaning out of the block work cores prior to core filling, reinforcing and starter bars being incorrectly located in cores and core filling not fully filling the cores due to inappropriate aggregate size, inadequate slump or inadequate compaction. Problems can also occur with the brick biscuit faces or formwork to clean out blocks 'blowing out' if too great a height of block work core is filled in one pour or alternatively if the biscuit or form is not adequately braced.

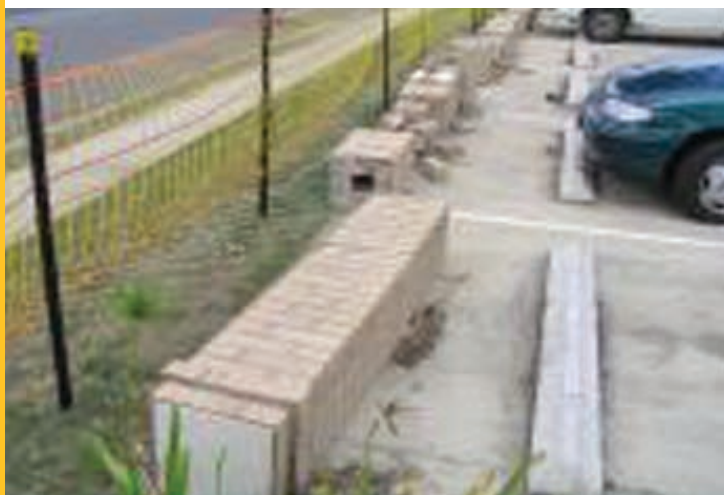
Brick work piers in fencing with no vertical reinforcing

Instances have occurred where fences have failed at the bed joint because there was inadequate or no reinforcing in the fence or its engaged piers. Excessive cracking is also often encountered in block fences where cores have been inadequately reinforced or core filling is defective.

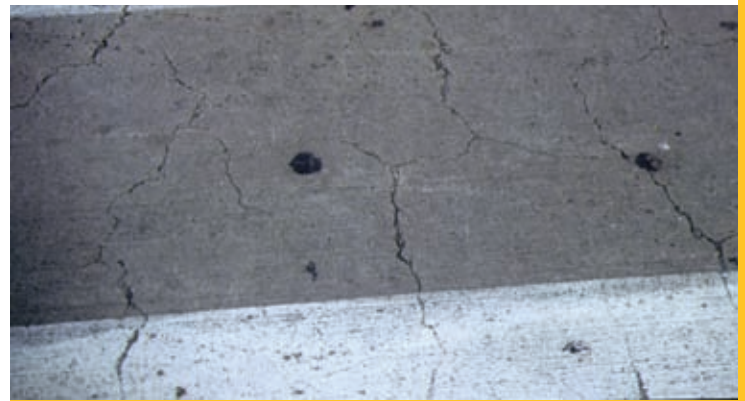
Plastic shrinkage cracking

Although they may not become visible until the day after finishing these cracks start to form before the concrete sets and are typically 300 to 600mm long and up to 3mm wide. The primary cause of plastic shrinkage cracking is rapid evaporation of the surface (bleed) water from the concrete leading to premature drying and subsequent cracking of the slab.

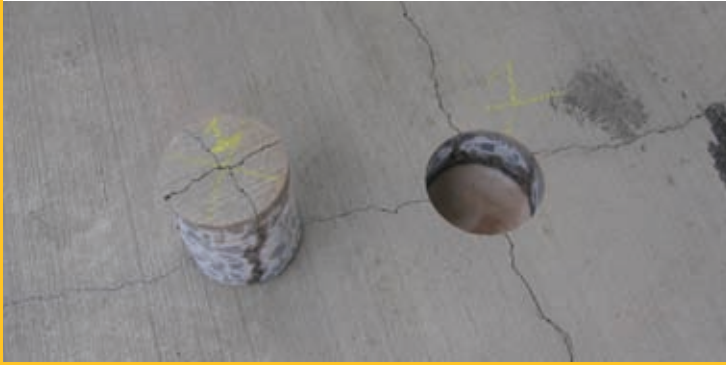
Plastic settlement cracking

Plastic settlement cracking is caused when concrete settles under its own weight often without adequate compaction. As the concrete settles it is restrained by reinforcement or service pipes etc and cracks form. Unlike plastic shrinkage cracking which is often random, plastic settlement cracking usually follows a distinct pattern often mirroring the placement of reinforcement. Site practices that will minimise the likelihood of plastic settlement cracking occurring include;

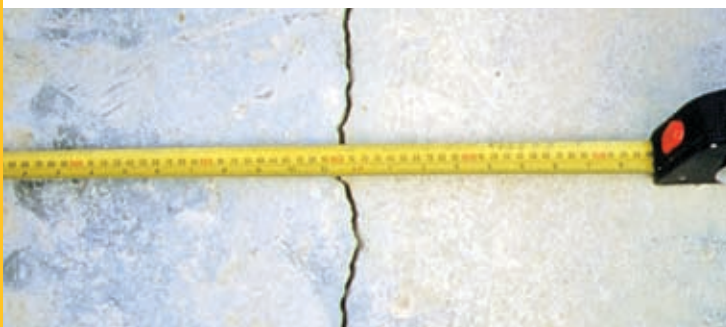
Drying Shrinkage Cracking

Drying shrinkage cracking is primarily caused by the concrete drying out and shrinking. If the concrete is restrained through formwork, adjoining walls, reinforcement and by sub-grade surface friction cracks may occur.

Two issues, namely the water content of the mix and the location and timing of installation of joints, contribute significantly to the likelihood of drying shrinkage cracking occurring. Excess water in the mix increases the amount of shrinkage that is likely to occur and inadequate or incorrectly located joints and joints that are cut into the surface too long after the concrete is finished do not provide sufficient ability for the slab to accommodate the shrinkage without cracking. Site practices that will minimise the likelihood of drying shrinkage cracking occurring include;

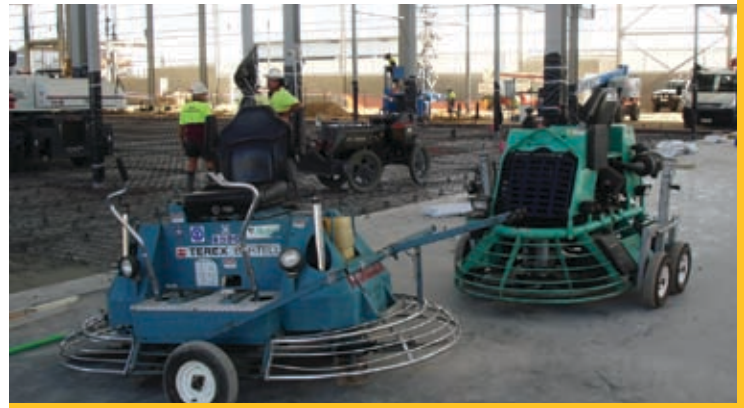
Ride-on mechanical trowelling machines

- Use a walk behind power floating machine for the first pass to aid surface levelling before subsequent passes using ride on machines.

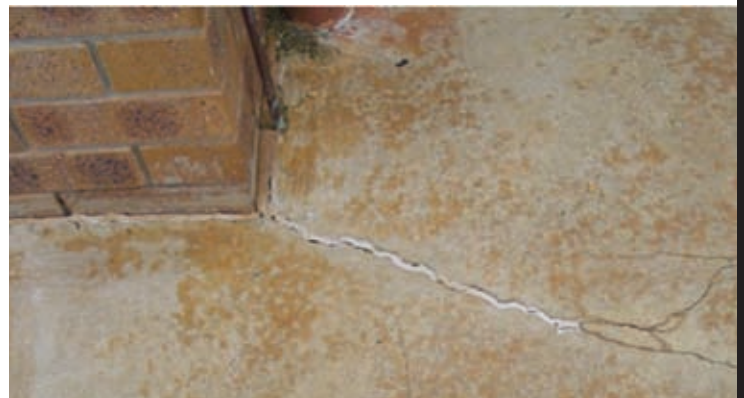
Cracks occurring at change of direction

In residential driveways and external slabs control joints should generally be installed at 3m centres in both directions, at any change in direction (eg corners), at change of shape (eg connection of a narrow path to a driveway) and at any rigid structures that may prevent movement and risk cracking (eg protruding column or nib wall).

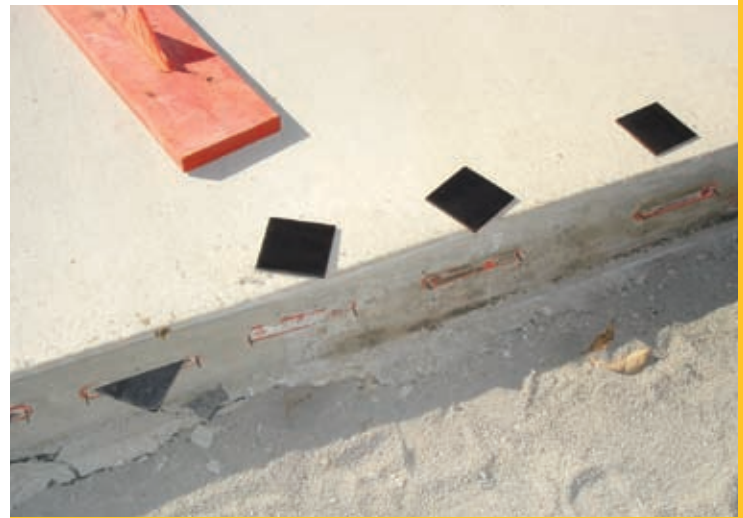
Engineer designed construction joint

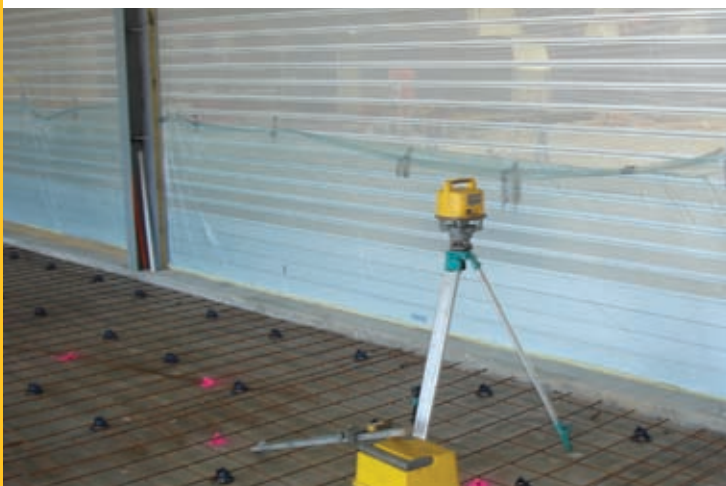
Plastic Film Protection over Roller Grilles

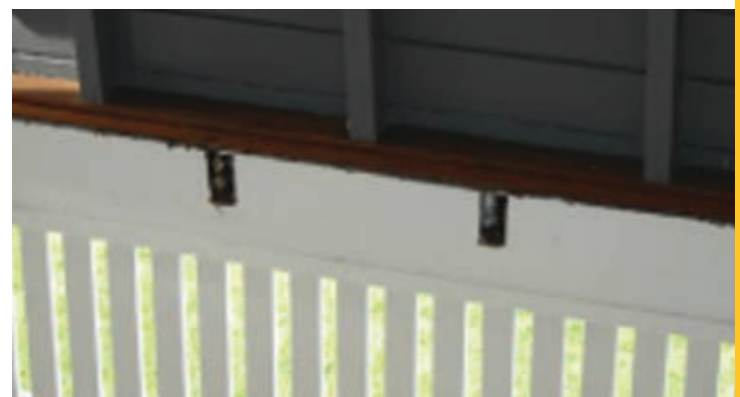
Housing in the bearer

Cause of Collapse - Over a long period of time the external balcony bearer deflected outward due to the inadequate restraint provided by the nail fixings into the bearers. Corrosion of the nails may have contributed to the inadequate restraint. As the bearer deflected outward the joists began to be displaced from their housing in the bearer and this is evidenced by paint on the ends of joists and into the bearer housings.

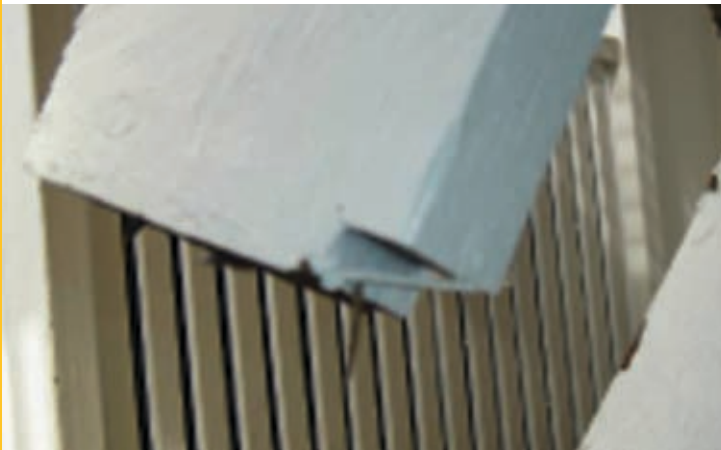
Paint clearly evident inside the cog in the joist.

In fact paint witness marks indicate that on a small number of joists the full depth of cog measured to be approx. 18 to 20mm had disengaged from their housing due to an outward deflection of the main bearer.

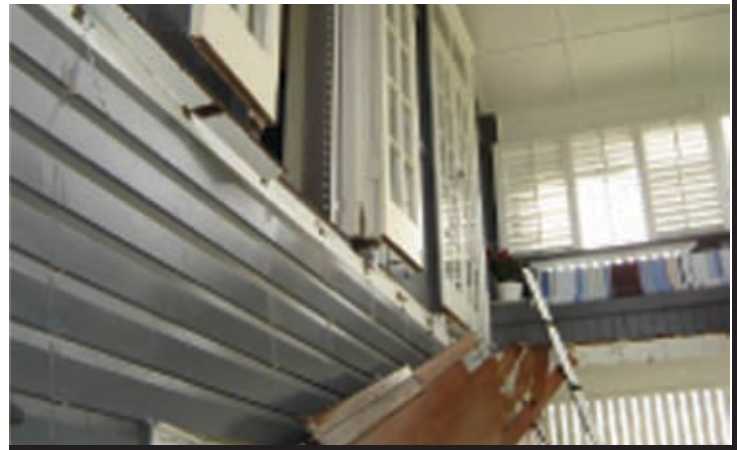
View at internal wall of home external bearer support

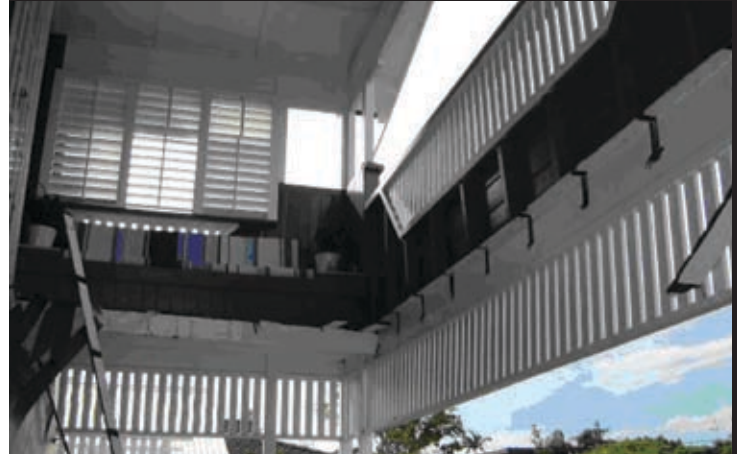
View of external bearer support

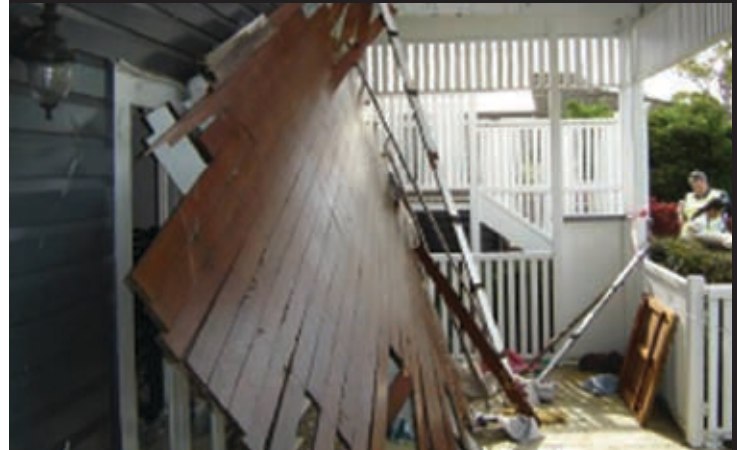
View of collapsed deck

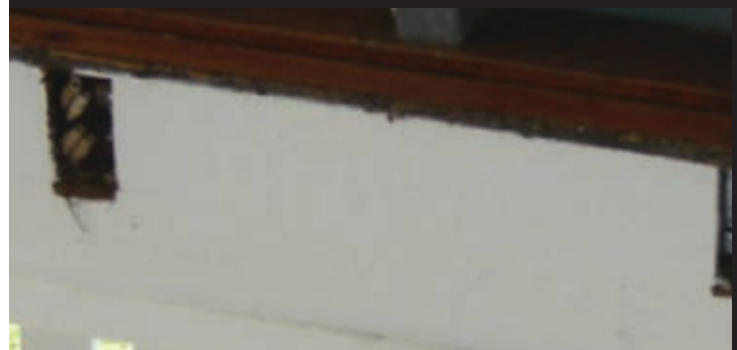
Mud wasp nests in bearer housing is evidence that a sizeable gap existed where the floor joist cog was not fully engaging into bearer.

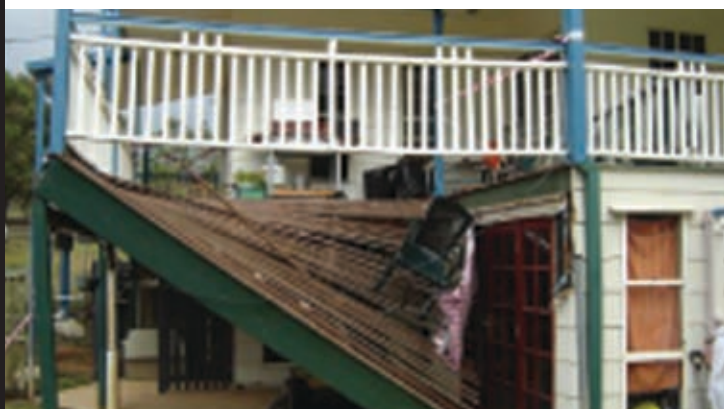
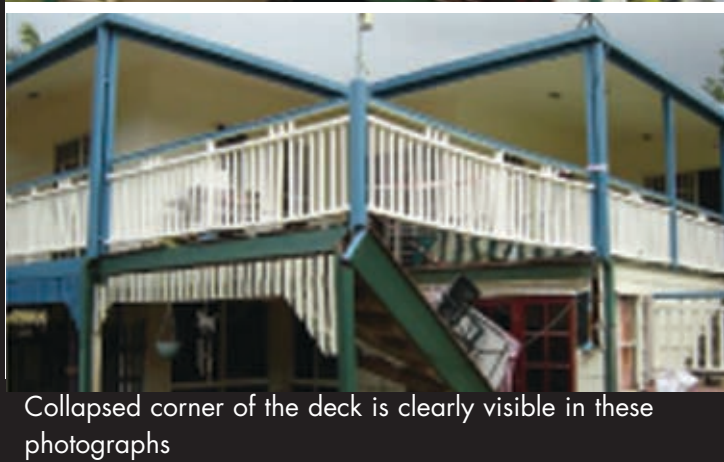
Collapsed corner of the deck is clearly visible in these photographs

Cause of Collapse - It appears that the south-west corner of the deck failed initially where the deck bearer was attached to the main dwelling. It was further found that the deck bearer that failed penetrated the external cladding boards and relied upon support by multiple pine corner wall studs in the wall cavity. The pine wall studs supporting the bearer were found to be totally rotted out due to the ingress of water into the wall frame.

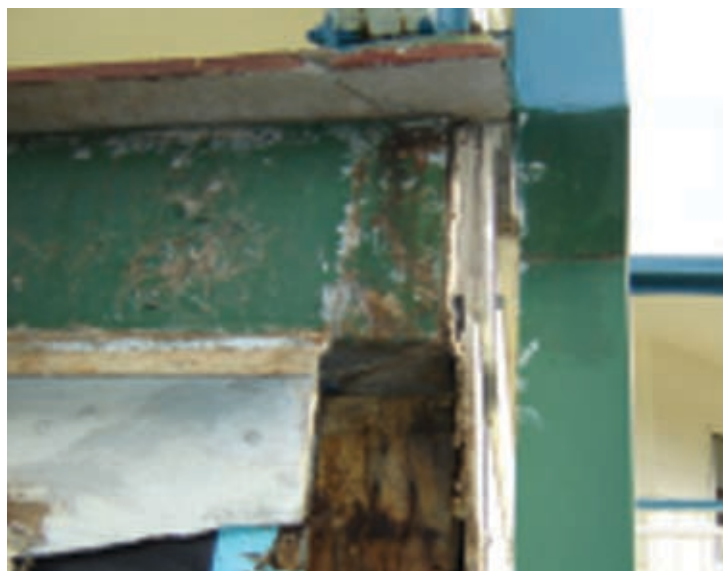
Support point for the bearer

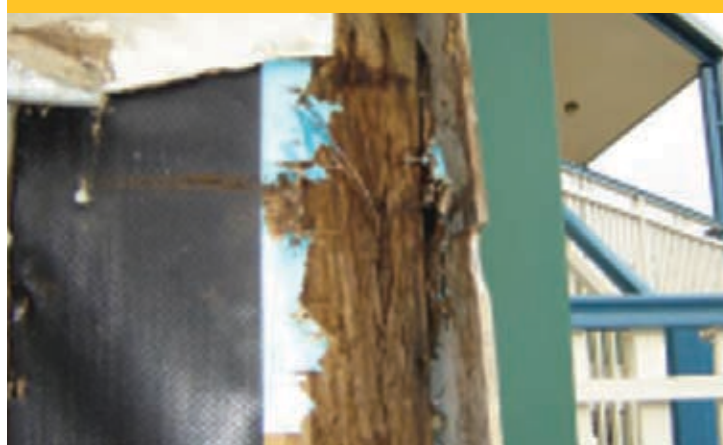
Rotted wall studs below the bearer support joint

When a substantial load was applied to the deck in the direct vicinity of the south-west corner over the bearer being supported by rotted wall studs, the inadequate support allowed the bearer to rotate downwards and the collapse occurred.

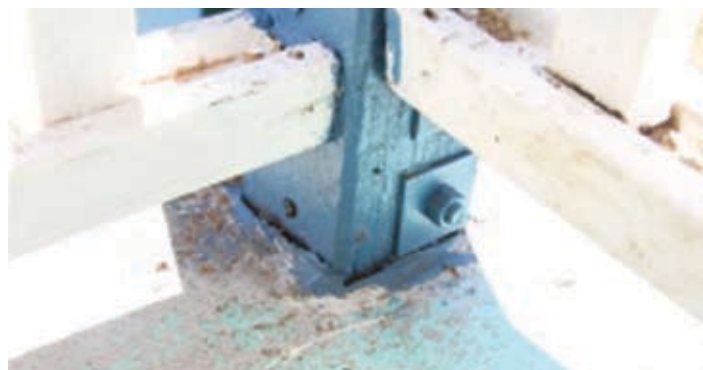
Gaps around base of veranda post allow water ingress into wall cavity

The ingress of water may have occurred where the bearer itself penetrated the wall cladding and also around the base of a timber veranda post of the main dwelling which was located directly above the location of the bearer. These points of water ingress relied solely upon sealant to prevent penetration of water.

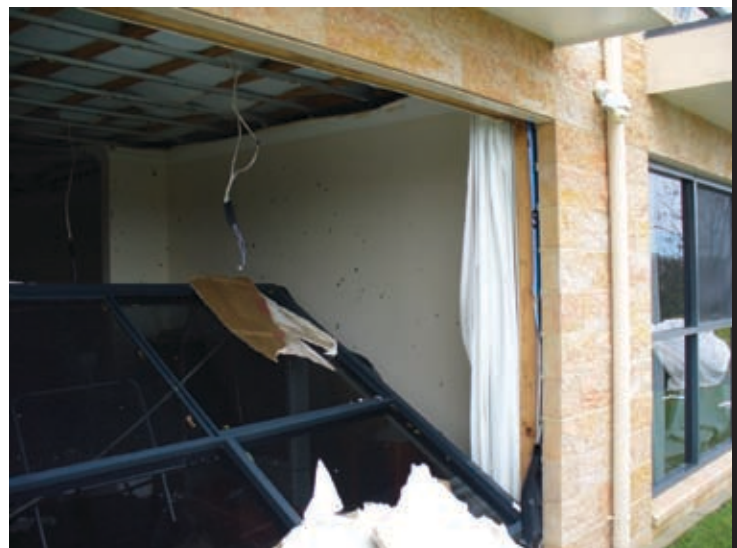
Whole window assembly blown in without breaking the glass

Following the severe storms that impacted upon The Gap in Brisbane in 2008 inspections by engineers from the James Cook University, Cyclone Testing Station and other regulatory organisations were alarmed to find that window and door frames had blown in as whole units, due to inadequate fixings. This subsequently caused large openings, allowing wind and water inside.

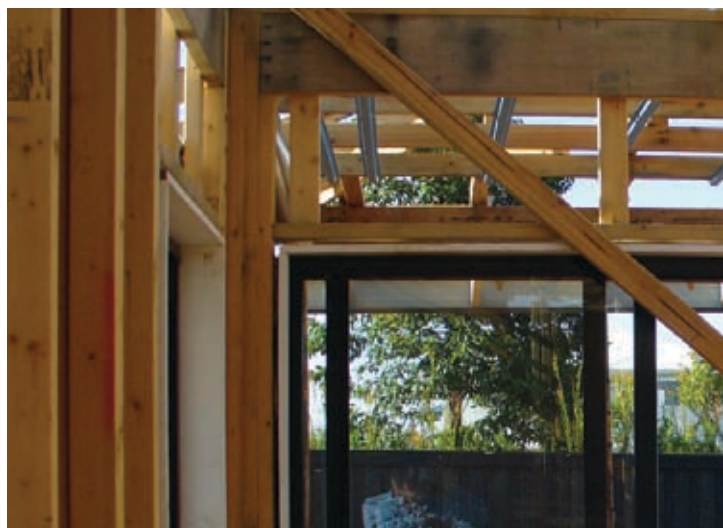
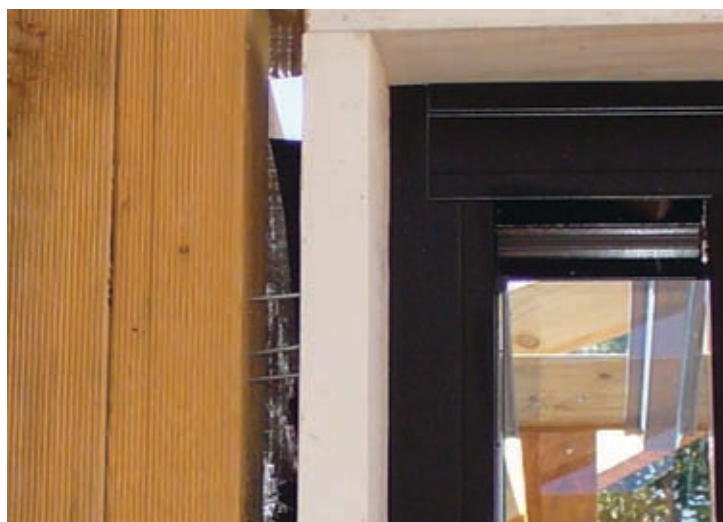
Inadequate fixings - excessive gaps, no packing, nails too short to bridge the gap and securely fix to the frame

Further investigation of the 'as installed' details for the failed window and doors revealed that in almost all instances the frames had not been properly fixed. Gaps around the frames were inconsistent ranging from 0 to 30mm, packing was rarely used and nails were typically 50mm in length which was inadequate to extend through the frame, across the often large gap and fix securely into the timber studs.

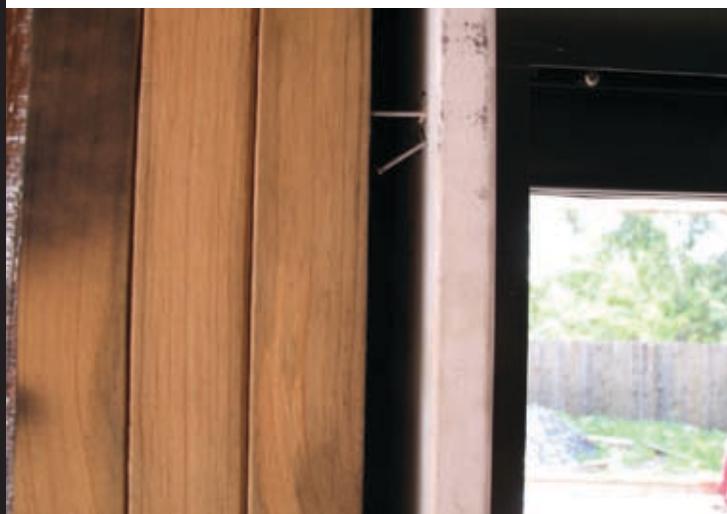
Inadequate fixings - excessive gaps, no packing, nails too short to bridge the gap and securely fix to the frame
