# Salt attack and rising damp

## A guide to salt damp in historic and older buildings

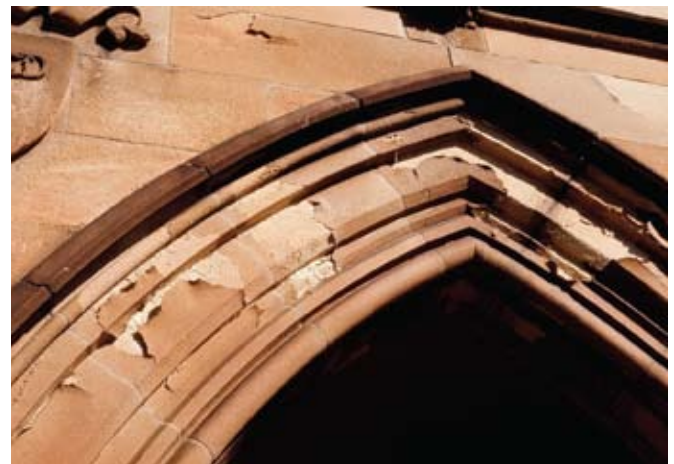
**Figure 3** Inappropriate use of water repellent coating, trapping moisture and salts and causing loss of the sandstone's natural case-hardened surface. Beneath this 'skin' the stone can be quite weak.

Anything that prevents a masonry wall breathing will reduce its life expectancy. Coatings that are designed to seal the surface of masonry walls (and so 'protect' them) risk trapping moisture behind the coating and causing a damp problem elsewhere, such as on the other side of the wall. If there are appreciable salts in the wall, the damage caused by the inappropriate use of coatings can be dramatic (Figure 3).

However, when the rate of evaporation is much greater, the evaporative front will be inside the wall and salts will crystallise within the pores of the masonry (subflorescence). The force exerted by rapidly crystallising salts is very high and sufficient to disrupt even the strongest masonry material. Crystal growth leads to either grain-by-grain loosening, which produces fretting and crumbling of the surface (particularly to soft mortars) or to delamination of a complete skin, such as the case hardening found on many sandstones (Figure 3) or the fireskin on bricks (Figure 5).

**Permeable masonry.** People have sought to make masonry materials impermeable by applying water repellent coatings, which have led to many failures as moisture and salt are trapped behind the coatings (Figure 3).

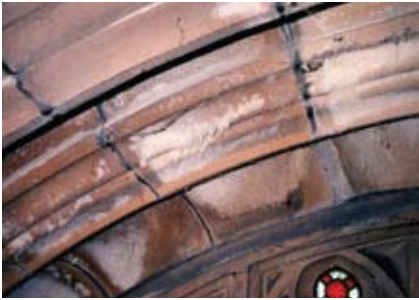
**Figure 4** Thin needles of salt extruding from the top of a window arch. A slipped roofing slate punctured the copper roof gutter, allowing rainwater to wash salts into the stonework.

When the rate of evaporation from the wall surface is low (such as in humid climates, or in cellars and basements with little air movement) the evaporative front may be at or very near the surface, in which case salt crystals will grow as long thin needles, extruding from the wall face (Figure 4). This is known as efflorescence and is commonly seen as a relatively harmless white powder on the surface of new brickwork.

As with rising damp, the damage caused by falling damp happens not where the moisture enters the masonry, but at the point where it evaporates from the wall surface and leaves the salts behind (Figures 4 & 14). Tracing damp back to the point of entry can be difficult, particularly when the masonry is rendered and/or painted and the moisture is trapped behind the render or paint coating.

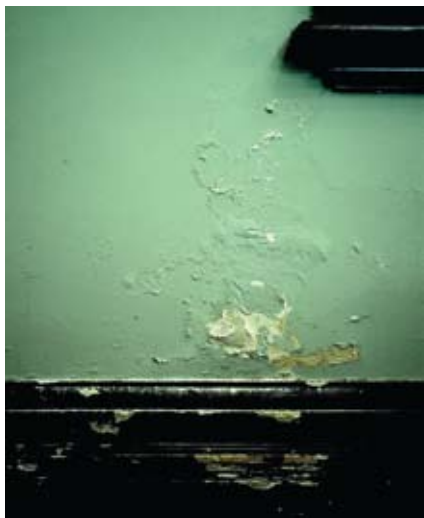
**Figure 7** Typical blistering of paintwork and damage to internal plaster due to the combined effects of rising damp and salt attack. The skirting is a cement moulding and also shows salt damage.

Rising damp may show as a high-tide like stain on wallpaper and other interior finishes, and when more severe, as blistering of paint and loss of plaster (Figure 7, and also Figure 15). Musty smells are common in poorly ventilated rooms and particularly in cellars and basements (see Box 1: *Damp rooms may be unhealthy*). Externally, a damp zone may be evident at the base of walls with associated fretting and crumbling of the masonry (Front cover & Figure 2).

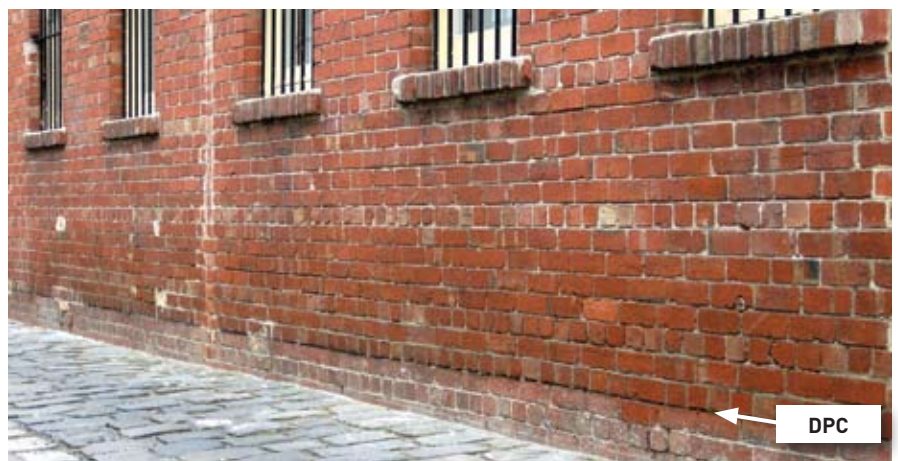
**Figures 15 and 16** In both these examples of penetrating damp the walls are wetter above the DPC than below. At right moisture is penetrating horizontally from a concrete floor, while on the left (in a basement) moisture is coming through the wall from the ground outside. Had the left hand example been an external surface, the paint would have prevented rain from flushing salts out of the wall.

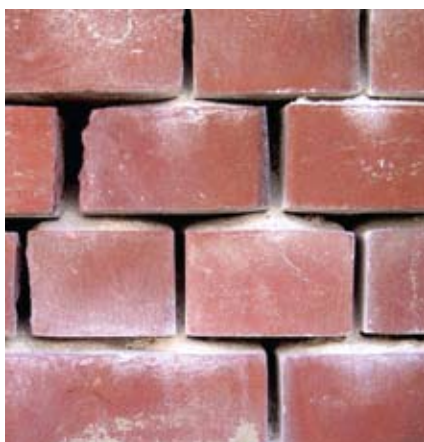
**Figure 18** Extensive loss of lime mortar due to salt attack. The bricks remain sound — protected by the weaker mortar. Any further mortar loss risks local collapse of the brickwork. Successful repair may require dismantling and reconstruction as is done when undersetting (See Section 16.1).

There is a long period of almost no decay (in this case about 80 years) during which time salts are slowly accumulating within the masonry. Only then do they fill the pores sufficiently to cause significant salt attack decay. By the time the house turns 100 the decay has accelerated to near its maximum rate (the slope of the line), and in only ten more years the decay will be twice as bad as it is now. There are two important lessons from this. The first is that procrastination is not an option — something must be done, and done soon, or sufficient mortar will be lost to cause partial collapse of the walls (Figure 18).

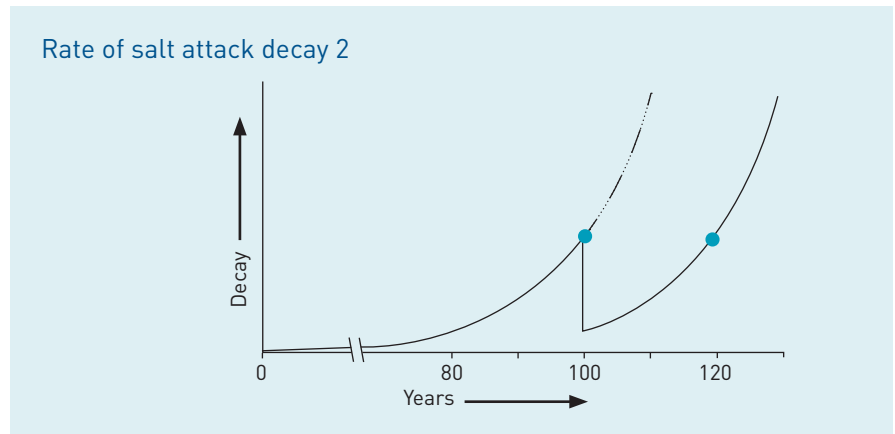
**Figure 19** After 100 years decay is reaching its maximum rate and something must be done. By putting mortar back in the walls and by removing the salts we can reset the decay clock back twenty years. The vertical line at 100 years does not go all the way to the baseline because it is impractical to remove all the salts. This is an approach which requires ongoing maintenance — every twenty years in this hypothetical case.

Repointing, the process of putting mortar back into joints between bricks and stones, is relatively straightforward. Removal of the salts can be achieved partly by raking out the weak mortar containing the salt and partly by desalinating the masonry, though we will never get all of the salt out which is why the vertical line does not go all the way down to the baseline.

Clearly, this treatment does not cure the salt damp — instead it is a maintenance approach of managing the problem and preventing it from getting worse. Like any maintenance it will require periodic renewal — in this hypothetical case, every twenty years.

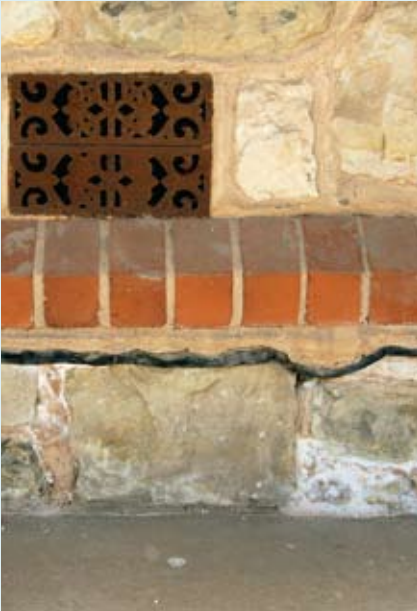
### Contaminated materials

Beware of contaminated materials such as sands and other aggregates. Chemical analysis of the strong efflorescence in the photograph shows it to be predominantly magnesium sulphate (epsomite), a very soluble salt. Its origin is almost certainly from contaminated dolomite quarry sand used as a bed for the concrete paving in the foreground. A former quarry produced a dolomite aggregate for concrete and roadmaking and the crusher fines (quarry sand) were widely used as a bed for paving bricks and concrete. Some parts of the quarry contained pyrite (iron sulphide) which, on exposure to the atmosphere after crushing, oxidised to liberate sulphuric acid.

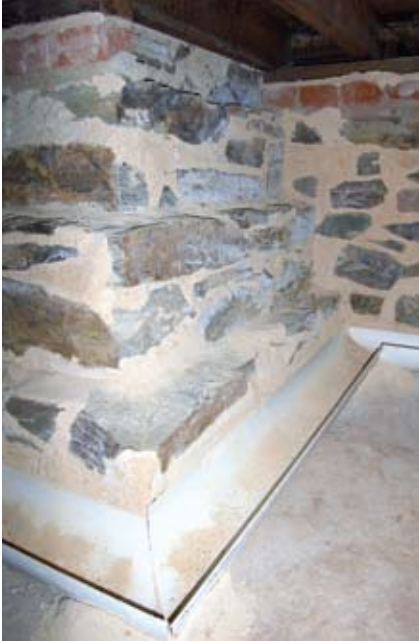
**Figure 27** Semi-circular sections of PVC piping catch salt and other debris from sacrificial plasters and mortars on the walls beneath the floor of a church. Bedded on the same sacrificial mortar mix as that used for the walls, the pipes prevent the recirculation of the salts through the soils below and are cleaned out annually. White salts are visible on the stones in the centre of the photograph.

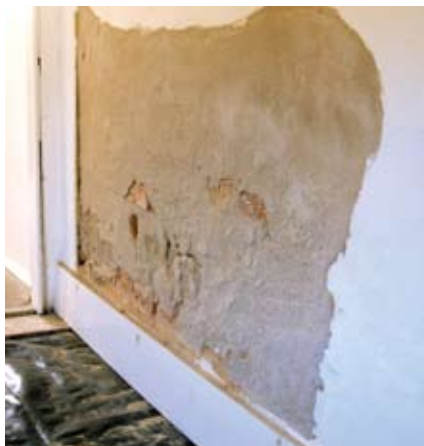
**Figure 31** Sacrificial plaster decaying as intended. Plastic sheeting is used to catch the salts and prevent their recycling through the soils and walls.

As they crumble, sacrificial mortars and plasters will produce a dust of sand, lime and salt which should be collected and periodically removed, rather than allowing the salt to re-enter the soil and so be recycled up the wall. When protected from rain strike (internally, in a cellar, or on a veranda) a drop-sheet of strong plastic sheeting can be useful (Figure 31). An alternative treatment, using half round PVC piping beneath a timber floor is shown in Figure 27.

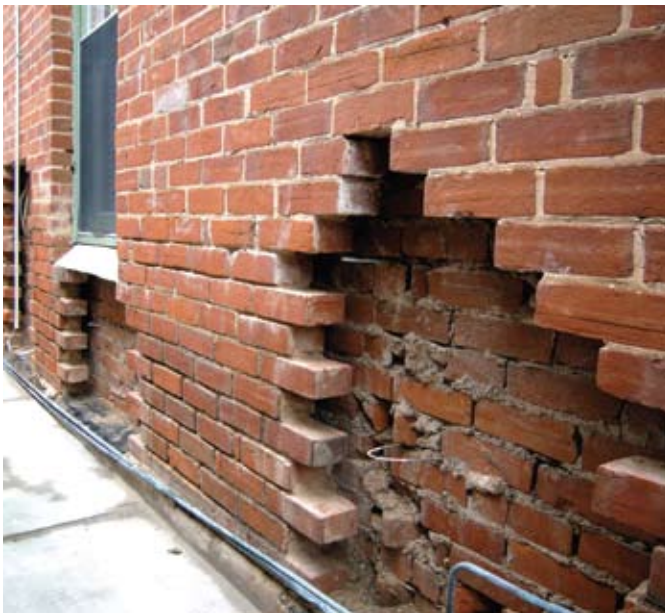
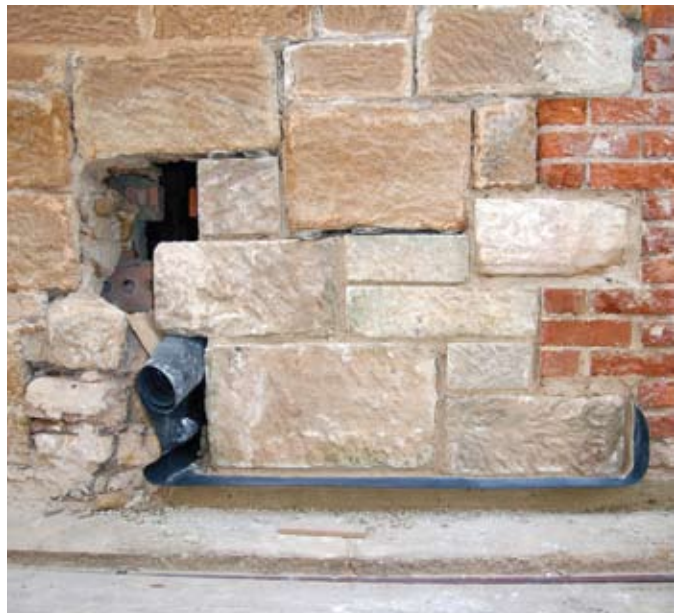
**Figures 35 and 36** Undersetting to install new damp-proof courses. At left sections, known as pins, are removed from a cavity wall, while at right a pin has been rebuilt on a plastic DPC, the end of which is rolled up ready for use in the next section. In the case of cavity walls, such as at left, the inner leaf also needs to be treated, using one of the methods described in this guide. Where solid walls are being underset, such as on the right, the entire thickness of the wall must be removed and rebuilt to allow a DPC to be installed across the full width of the wall. Partial undersetting of a solid wall is bad practice as the damp will continue to rise through the remaining portion.

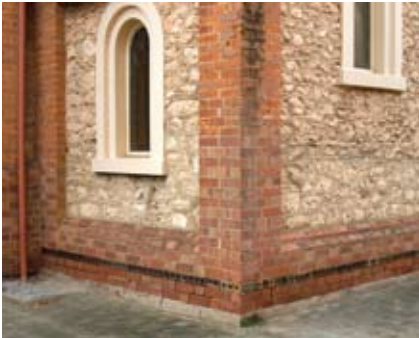
**Figure 37** Undersetting from the 1930s. New bricks and stones have been inserted up to a line above the window sill on the left. Bricks below the DPC are visibly damp (see also Figure 10).

The traditional physical means of introducing a new DPC is the technique known as undersetting, or masonry replacement. Undersetting should not be confused with underpinning, which is a treatment for structural cracking due to settlement or footing failure. In undersetting, sections of the base of the wall are removed down to the footing and progressively replaced with new materials and a DPC. Small sections (or pins) of brick or stonework are removed (including all decayed material), leaving pillars to support the wall structure (Figure 35). A DPC is incorporated as each pin is rebuilt; after the new mortar cures the top joint is packed tightly to take up the load of the wall (Figure 36). Adjacent sections are then removed and rebuilt until the whole wall has a new base incorporating a continuous DPC. Figure 37 is an example of undersetting carried out in the 1930s.

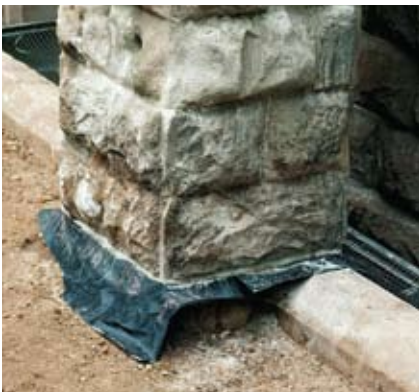
**Figure 38** Insertion of a DPC by slot sawing. A mortar joint is sawn out with a chainsaw allowing insertion of DPC sheeting. As salt-laden stone is left above the DPC, the technique must be combined with desalination to be successful.

DPC sheeting is inserted into the saw-cut, which is then packed with stiff mortar and tightly rammed to take up the load of the walls (Figure 38). After the mortar cures the next section of joint can be sawn out and work progresses around the walls. A potential problem with this method is the perforation of plastic DPCs owing to the (correct) use of sharp sands and the ramming necessary to pack the joint tightly. Thicker (0.75 mm) DPC material is recommended in these cases.

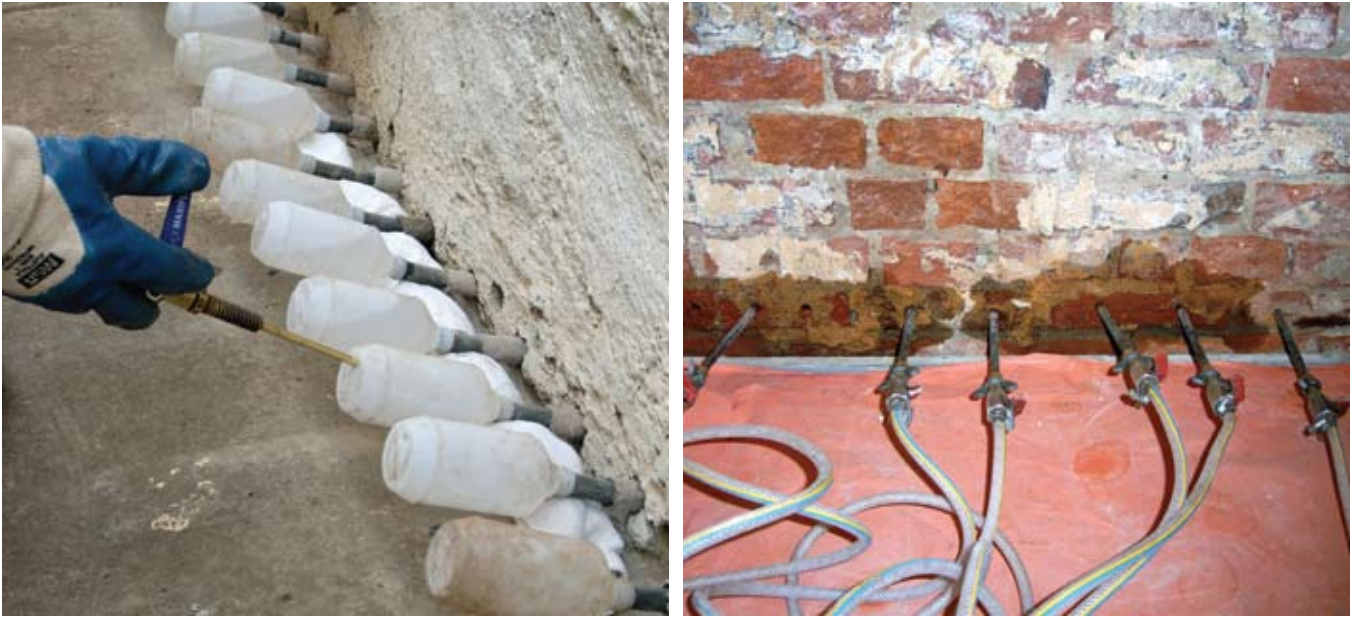
**Figure 41 and 42** Chemical impregnation. On the left: the gravity-fed system in which small plastic bottles are filled with a lance. Depending on the nature of the masonry and thickness of the wall the bottles are filled three and sometimes four times. Open holes just above the drilled line are used to indicate extent of penetration. On the right: low-pressure injection in progress on an interior wall from which plaster has been removed. Note the variation in the permeability of the brickwork; the brick on the left is already saturated and the lance is moved on while the central brick slowly fills with fluid.

Fluid is delivered into the holes by either a tube or a lance depending on whether it is to be gravity-fed or injected under low pressure (Figures 41 & 42). The choice of technique is to some extent determined by the nature of the masonry: gravity-fed diffusion is suitable for porous mortars and soft bricks, while normal bricks can be injected under low pressure (20–70 psi, 150–500 kPa). High pressure injection (greater than 150 psi, 1000 kPa) risks the blowout of weak mortars and imperfect coverage in sound materials due to viscous fingering, a process in which the fluid advances as a series of fingers, leaving gaps between.

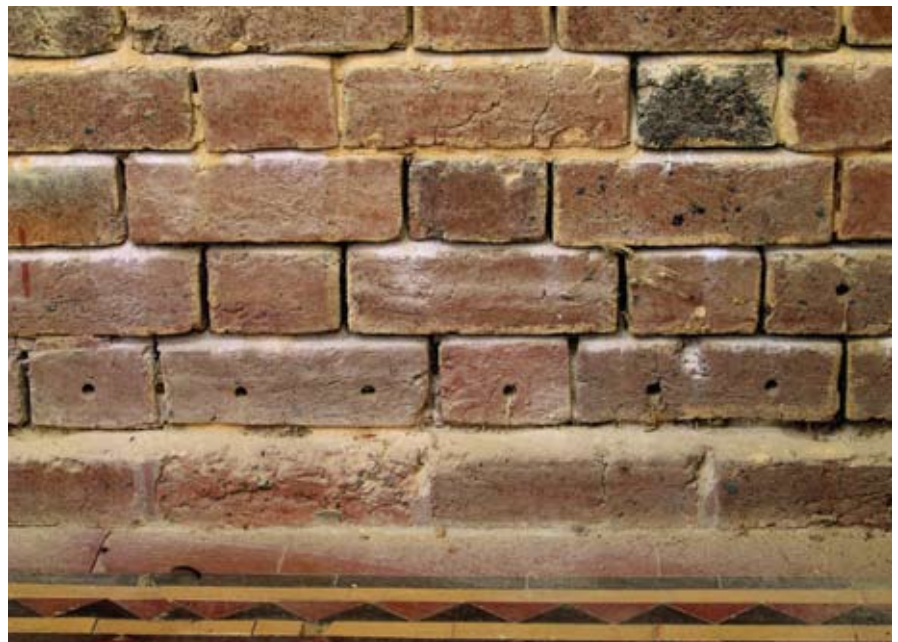
**Figure 43** Despite chemical impregnation, decay continues to the brickwork above the treated zone. This is because salts remain in the wall and can cycle in and out of solution with changes in humidity, causing ongoing salt attack decay. The yellow sand is what remains of a sacrificial mortar applied at the time of chemical impregnation. The white material is a mixture of the original lime mortar and salt. Further treatment should include raking out the salty mortar and repointing in a sacrificial mix and possibly poultice desalination, together with an assessment of the effectiveness of the chemical DPC. Note that extensive repointing may bridge the DPC, and so it may need re-treatment once the new mortar is well-cured. Alkaline-stable damp-course fluids should be used.

► See Sections 6, 13, 14 and 16.3 and also Figure 43.

Importantly, chemical impregnation provides only a barrier to rising damp; it does not prevent salts in the walls above the new damp-proof zone from cycling in and out of solution with changes in humidity, and so continuing to cause damage. **Chemical impregnation must be combined with sacrificial treatments and/or desalination for it to be a successful treatment for salt damp** (Figure 43).

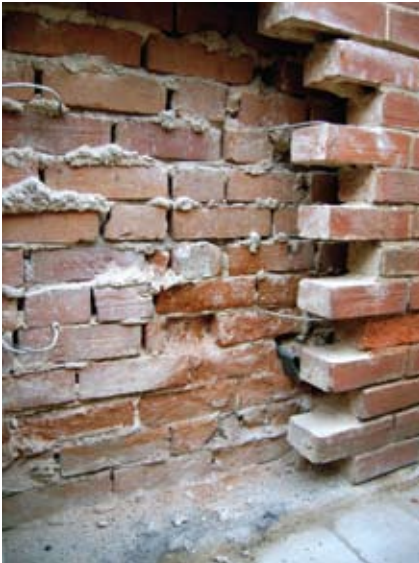
**Figure 45** Decay of an inner leaf of brickwork into the cavity. This would not have been discovered had the wall not been opened up for undersetting of the outer leaf. The decay means that evaporation is occurring in the cavity in preference to the interior of the house. Multiple paint coatings or previous repairs of interior plasters with dense impermeable materials may be an explanation. Whatever the cause, the implications of decay occurring where it cannot be seen are profound. The inner leaf must be treated, using one of the methods described in this guide.

Salt damp can be particularly problematic in cavity walls because of the risk of decay inside the cavity where it cannot be seen (Figures 45 and 46). In normal circumstances most decay should occur at the external surface of the wall (because that is where there is most evaporation — see Section 9.1: *Factors causing salt attack*). Some decay can be expected on interior surfaces, particularly if the rooms are heated and air-conditioned.

While Figure 45 shows an example of decay of an inner leaf, more severe decay is likely on the inside face of an outer leaf, as shown in Figure 46.

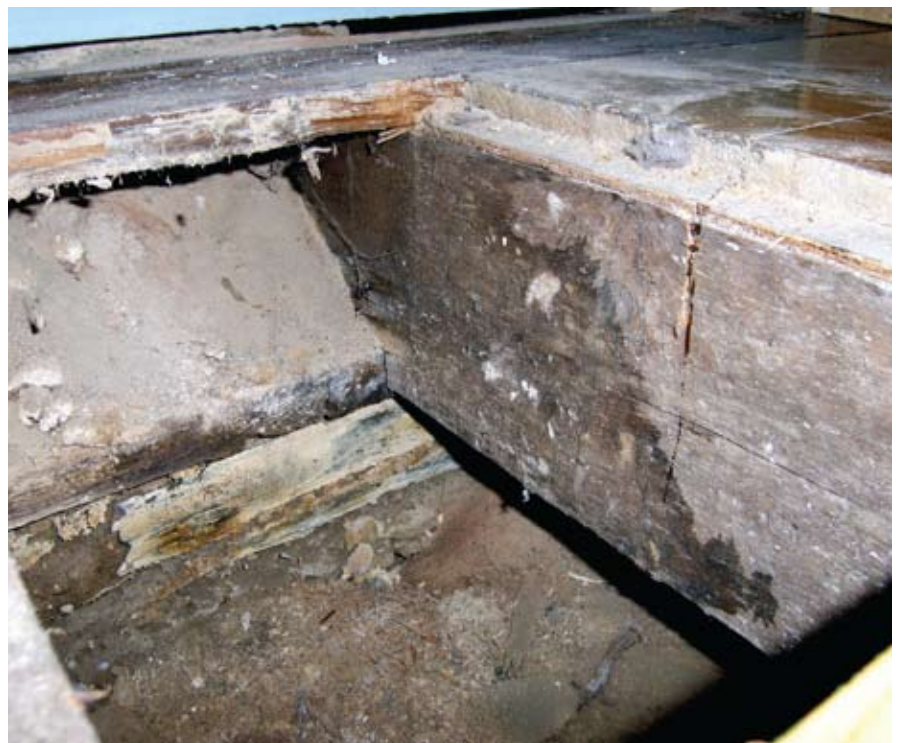
**Figure 49** The photograph at right is looking beneath a floor against a damp wall, and shows a wet zone on the timber joist and plaster debris on the floor plate, which is wet and rotten. The diagram below is a sectional view showing how the plaster debris drops behind the floorboards and sits on the floor plate. The debris provides a path or bridge around the DPC. Even though the DPC may have been only partially effective, the newly created bridge will add to the rate at which damp rises. And the salt that caused the first plaster to fail is being recycled into the wall where it will cause more damage. Furthermore, the plaster debris holds moisture against the floor timbers, increasing the risk of fungal rot and insect attack.

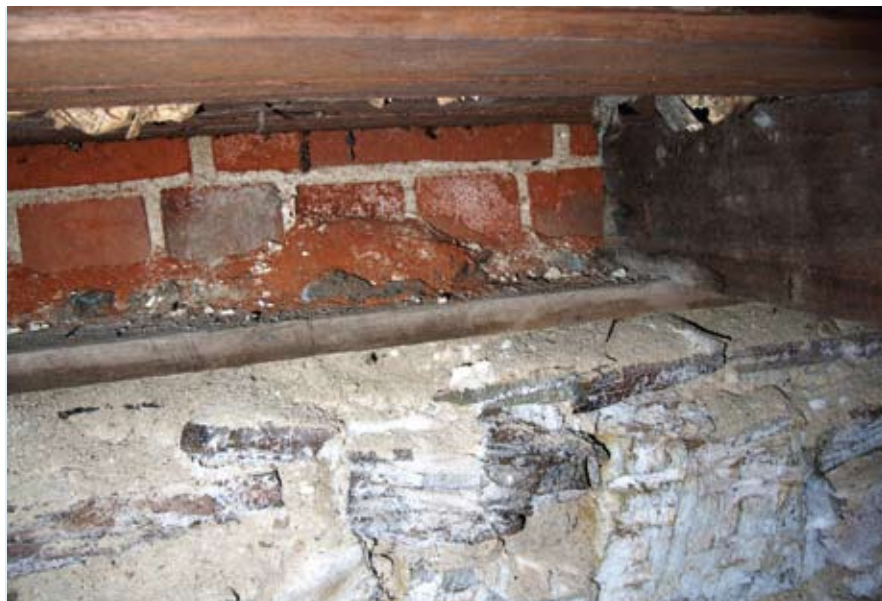
**Figure 50** Looking beneath a floor at the edge of a debris-covered floor plate. There are water stains on the end and base of the joist. Salt attack is damaging the bricks at the rear, which are slowly crumbling onto the floor plate. Dense salt crystals encrust the surface of the rubble bluestone in the foreground. The lack of a membrane beneath the floor plate means that the floor timbers are at greater risk of fungal rot and termite attack.

Whichever treatment is used, it may be desirable to apply a sacrificial plaster to the face of the wall below the new membrane. More thorough desalination will be required for very salty walls, such as that shown in Figure 50.

Figure 50 shows a similar view beneath the floor of another house. Salt attack is decaying the brickwork and the debris is accumulating on the damp floor plate. The brick debris overlies previous plaster material which has fallen onto and behind the plate, thereby making a bridge across the DPC which is located out of sight, directly behind the floor plate. Unfortunately the plate is not isolated from the damp masonry below, a situation that is common in Australian buildings. Note the extensive salt efflorescence on the face of the bluestone rubble.

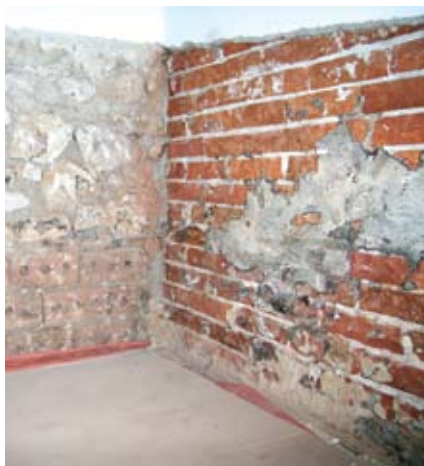
**Figure 51** Discoveries on removing plaster from interior walls. On the left, the brick-on-edge is a partial undersetting of the inner part of a solid wall, leaving the outer part untreated — a total waste of effort. On both walls, but more apparent on the right, are remnants of a dense hard cementitious material containing milled iron that was designed to rust and block pores, making it impermeable. Its removal proved extremely difficult.

This is when some unhappy discoveries may be made. The building may have been previously treated for salt damp and the discoveries may include corroded remnants of copper wire electrodes from a passive electro-osmotic treatment, replacement masonry from a partial undersetting of the walls, and hard impervious renders trapping moisture and salt within the walls (Figure 51). The hard render may have delaminated in places, leaving a film of salt crystallising in the space between render and wall (Figure 52). The render, which may have been formulated to be waterproof and may be an extremely hard mix of almost neat cement, will need to be removed to allow desalination.

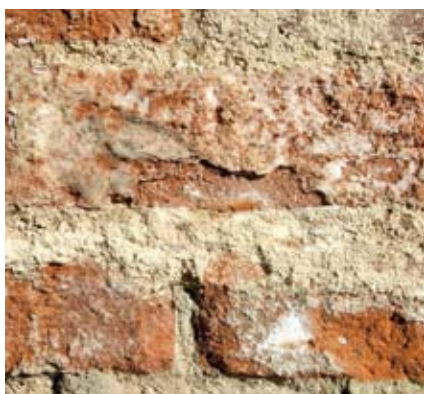
**Figure 52** A thick film of salt that crystallised beneath a hard render, which was in turn finished with a high-build (thick) paint coating. For evaporation (and hence salt crystallisation) to occur the render must first have become partially detached from the brickwork. Thermal cycling would then drive air movement, allowing evaporation. The salt was chiselled off and the brickwork poulticed before re-rendering.

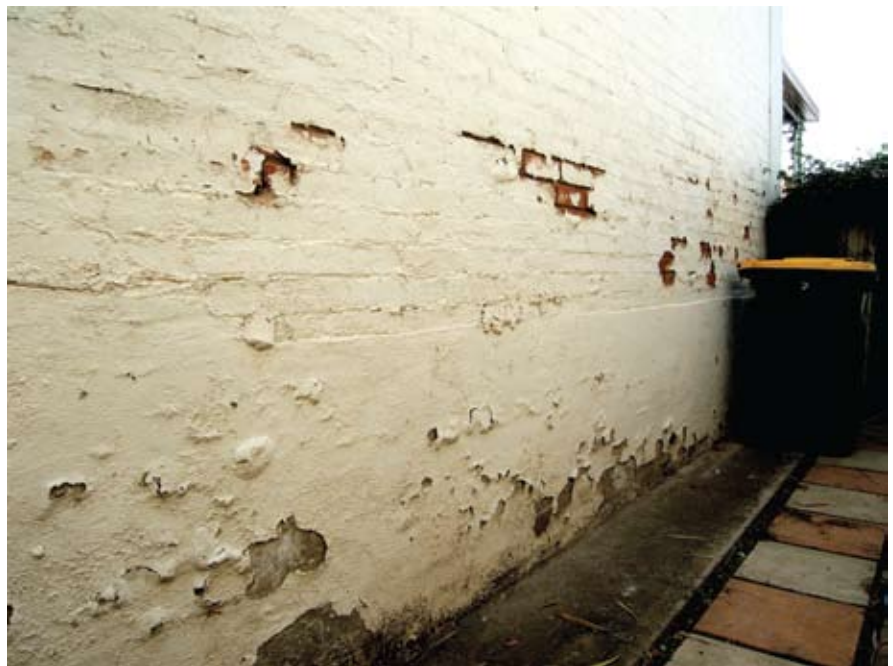
**Figure 54** Failure of an acrylic paint coating due to salt damp. The bottom part of the wall is rendered in cement, which has contributed to the damp rising further due to its relative (but not total) impermeability. Decay of the brickwork is focussed where the paint film fails because that's where salt crystallises as moisture evaporates. The paint and the render should be removed and replaced with a more vapour-permeable coating such as limewash.

The same principle can be applied to plasters or renders. By using weak plasters the evaporative front (and hence decay) is moved from the original masonry out into the new plaster. Provided there is sufficient evaporation from the sacrificial plaster, decay can be limited to the lower parts of a wall. These treatments are the opposite of the incorrect practice of rendering the base of affected walls with dense, relatively impermeable cement renders. This simply prevents the evaporation of moisture, which continues rising up the wall until it can evaporate above the render, starting the problem all over again (Front cover & Figure 54).

Acrylic (water-based) paints are more vapour-permeable than alkyd (oil-based) paints; the latter should not be used where walls remain damp or are still drying out after DPC insertion. Even the acrylics can be too impermeable for old walls (Figure 54). In these circumstances alternative coatings such as cement-based paints and traditional limewashes should be considered. Limewashes are more vapour-permeable than cement-based paints.
